2014 Reserves Fund Study Capital Replacement Plan

**University Woods Condominiums
Trailwood and Lineberry Drive
Raleigh, North Carolina**

**Owners: University Woods at
Centennial Condominiums Homeowner's Association**

Prepared by: Ted M. Sherrod, PE

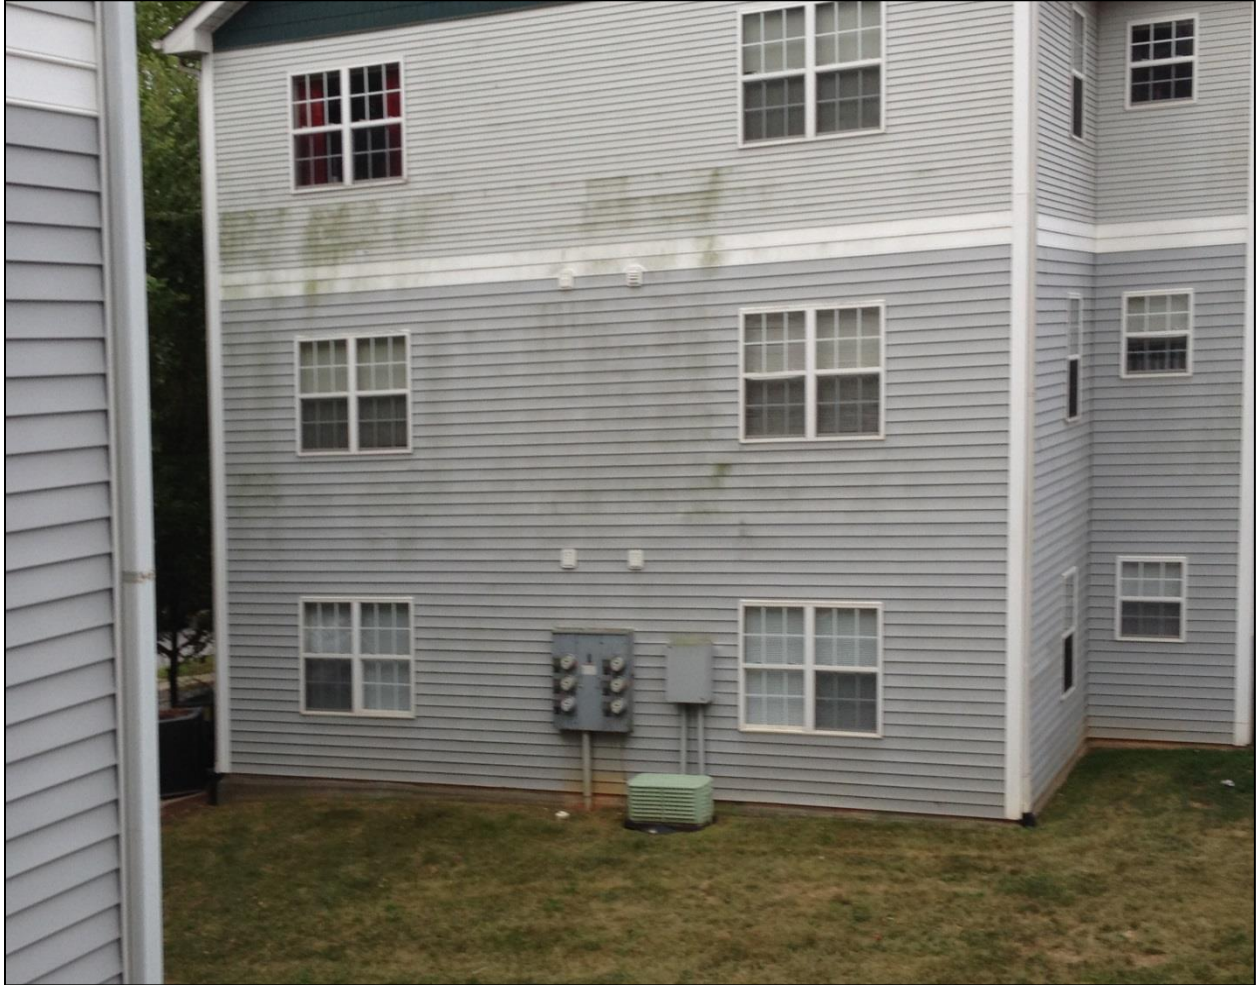
During the site review, the vinyl siding showed evidence of a need for thorough cleaning (as noted on the cover page photo), general repair/replacement due to wear, weed trimmer damage, and suspected vandalism, as well as investigation for damage by window reflections.

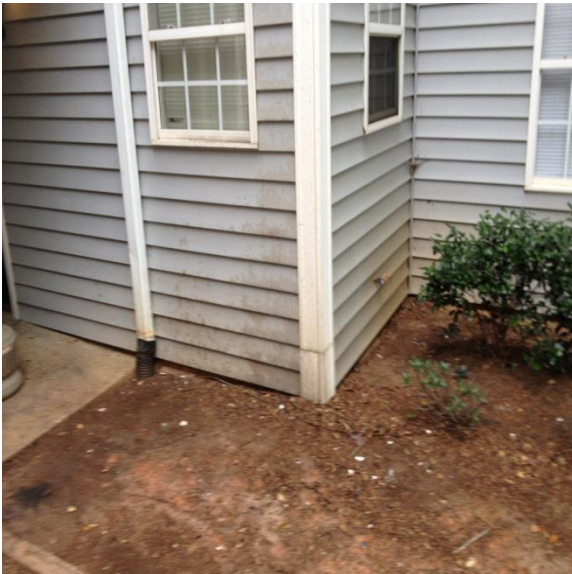
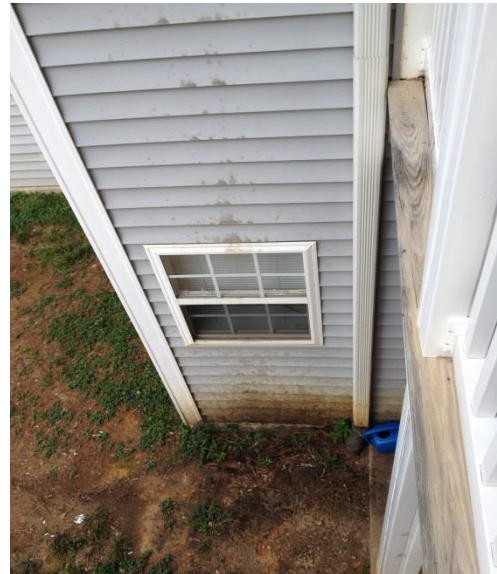
Photos showing condition of vinyl siding where gutters overflow onto the soil surface

While maintenance related activities were not scoped with this study, quotations were received or estimated for tree trimming, gutter/downspout cleaning, chemical cleaning, and repair (See Appendix F). The repair quotation contains the cost for replacing the vinyl damaged by window reflections. Industry reports that sunlight reflected off low emissivity, energy efficient windows can cause vinyl to melt. The vinyl contractor indicated that building

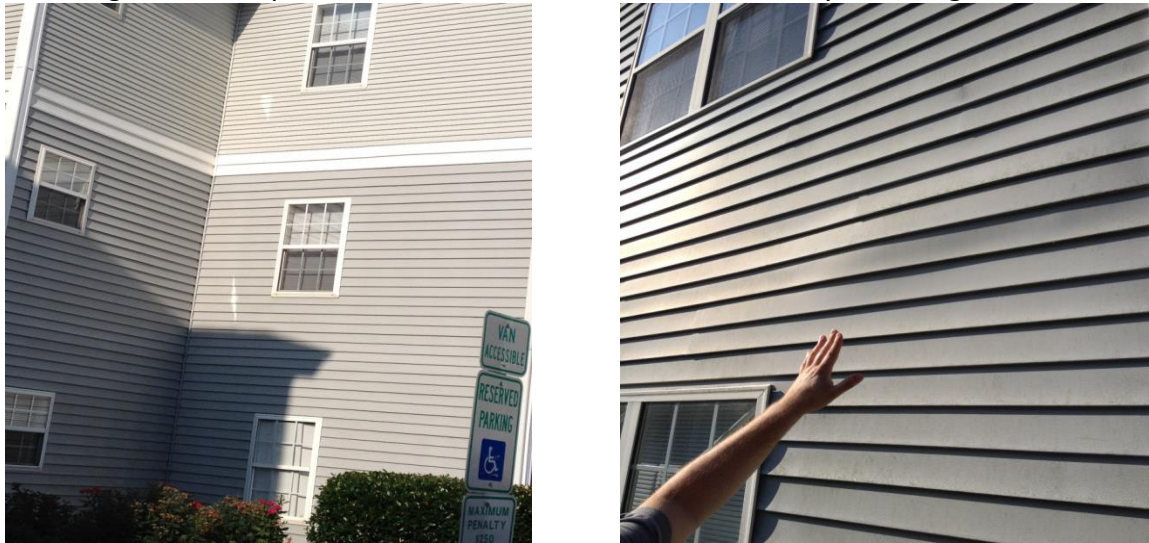
Photos showing window mirror reflection onto vinyl siding (left) and resulting damaged vinyl siding (right)

codes have now been modified to address this issue. The BOD may wish to pursue replacement of low emissivity damaged vinyl through warranty; the coverage continues to deflate over time as noted in the previous chart. Some manufacturer's no longer warranty damage from this phenomenon. Shaded window screens may be a long term solution.

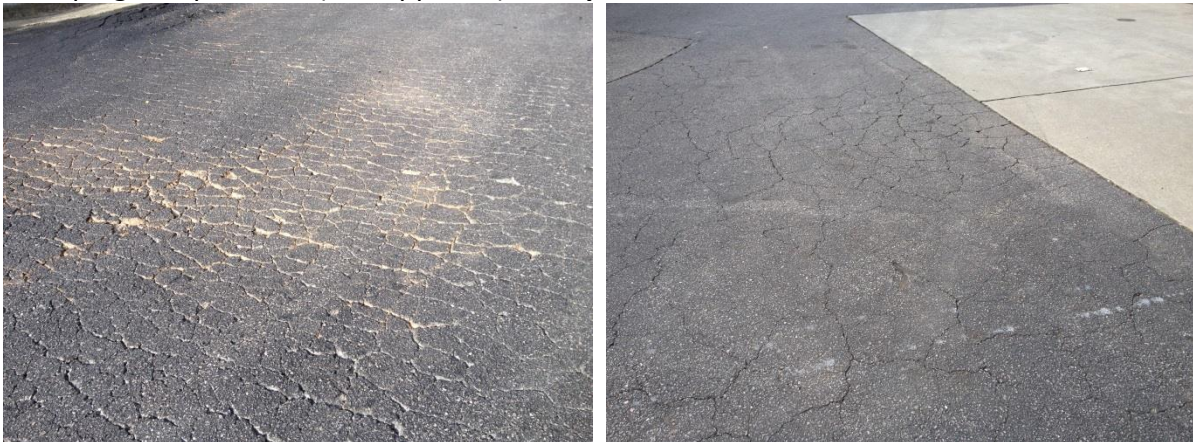
Photos depicting repairs needed at dumpster site near Wolf Tech Lane

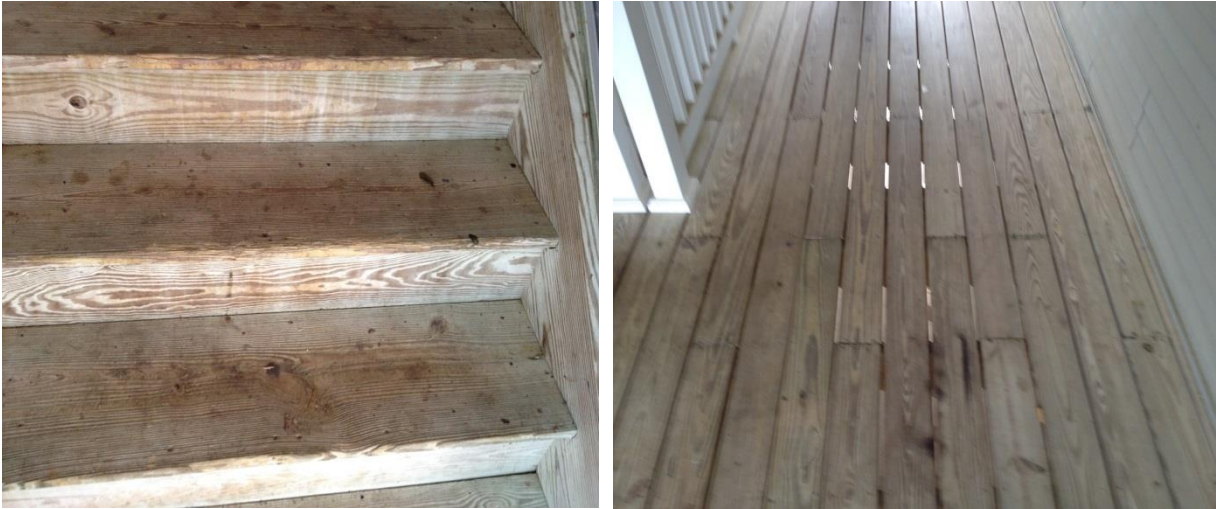
The building contractor stated that the wooden staircases should match the structural life of the building. The flight of stairs to the second floor shows the most wear, of course, with the flight to the third floor showing less wear or theoretically, half as much. A quotation was provided to replace the wooden stair treads and risers. The treads are recessed into the stringers and tedious removal would be required per tread and riser. More options may be available from other builders/contractors.

Wooden stairs with treads and risers (left) and wooden decking in breezeways (right)

The building contractor also reviewed the wooden decking for the second and third floor breezeways. The decking shows wear with evidence of some burned and some painted surfaces. A quotation was provided for the removal and replacement of the 5/4" treated decking.

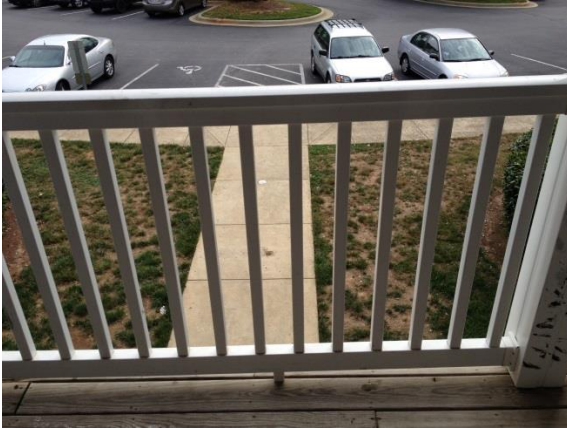
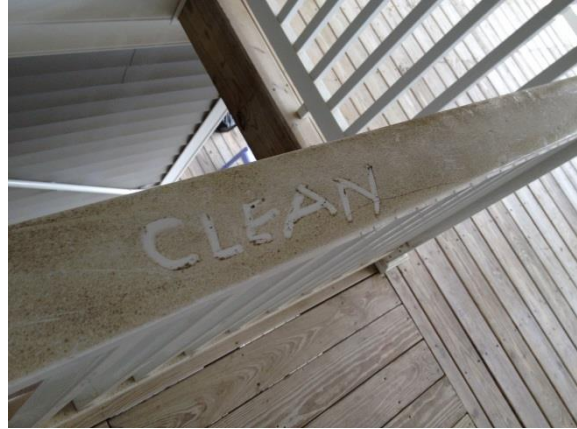
The PVC railing at the ends of breezeways and around the stairway shows wear, damage, and a need for a thorough cleaning. The building contractor provided a quotation to replace with PVC-like railing, as the existing style would be matched as closely as possible. (See Appendix E for quotations/estimates for these three components).

PVC railing in breezeways and stairways

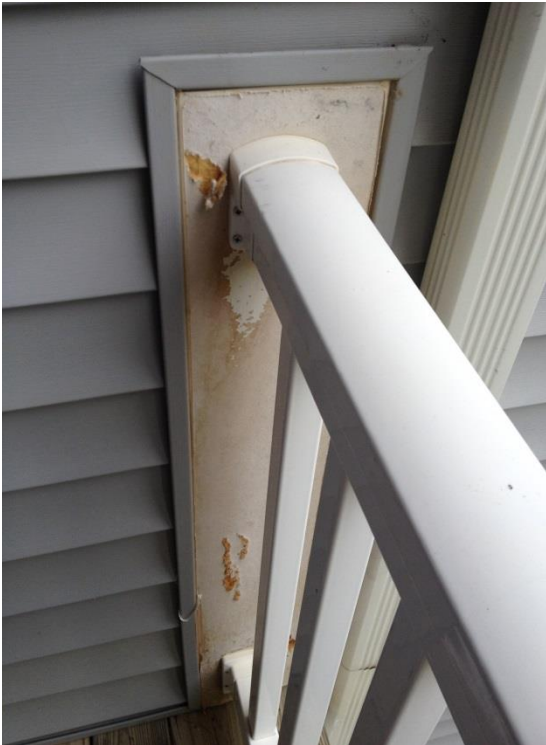
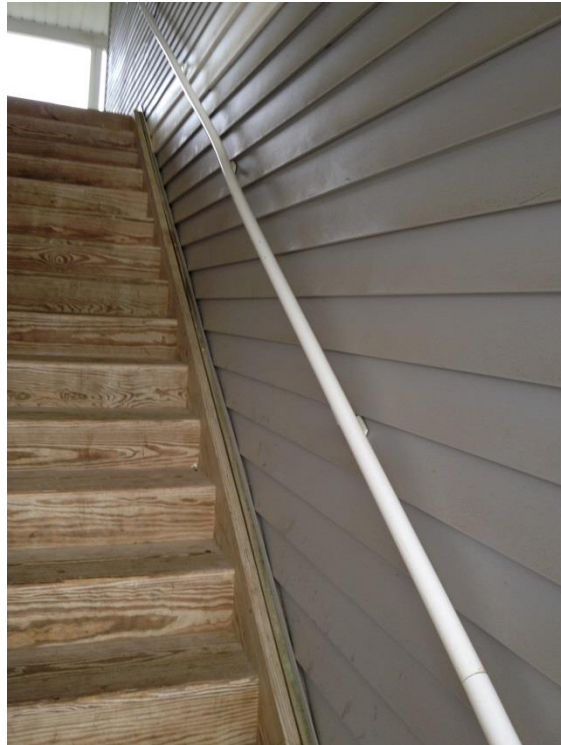
Rail connections showing deterioration with masonite (left) and vinyl handrail detached from wall (right)

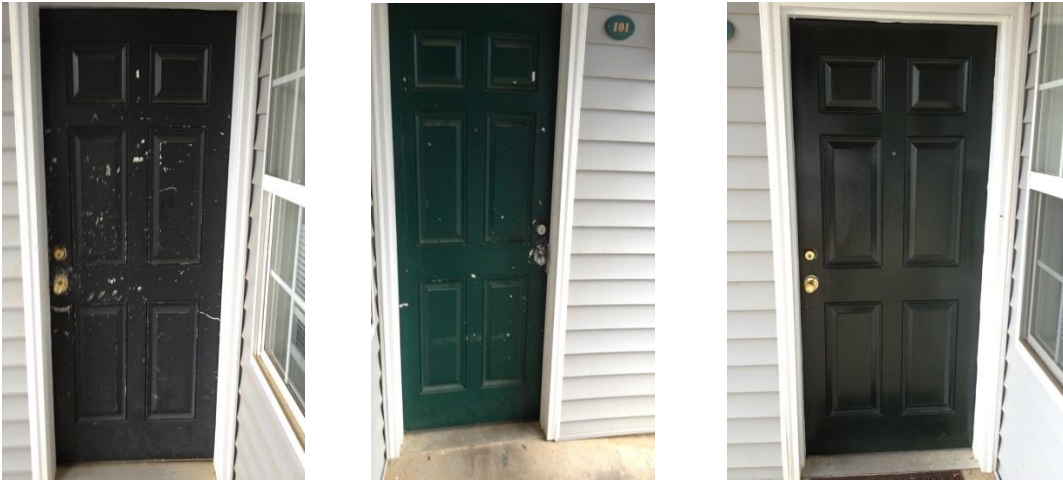
Examples of condition of door exterior finishes (left & center); good finish (right)

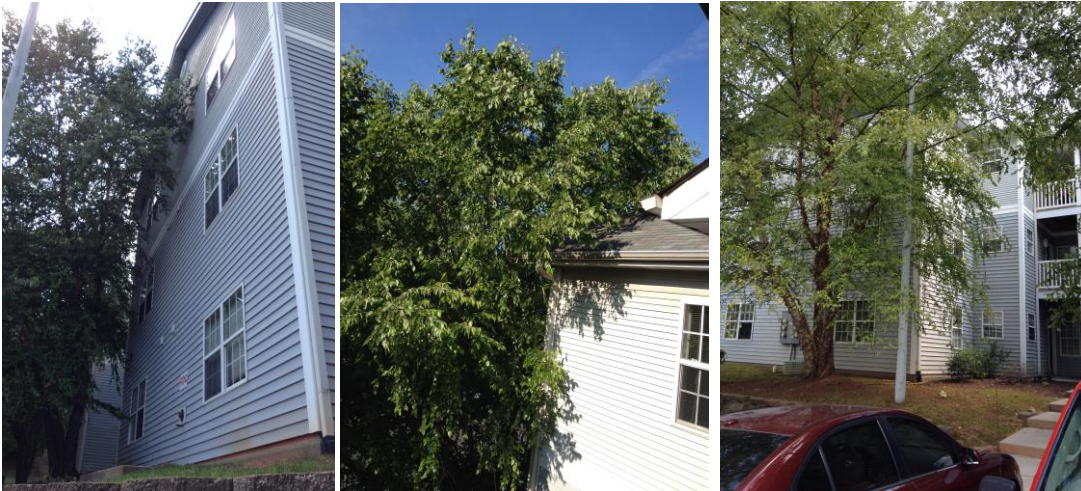
Examples of trees impacting gutters, roofing, and siding
